Subject: Department of Natural Resources Washington Geological Survey,
School Seismic Safety Assessment Project, Contract No. AE 410 -
Seismic Evaluation for **Port Angeles School District**

School Buildings Evaluated in the Port Angeles School District

1. Roosevelt Elementary School, Main Building

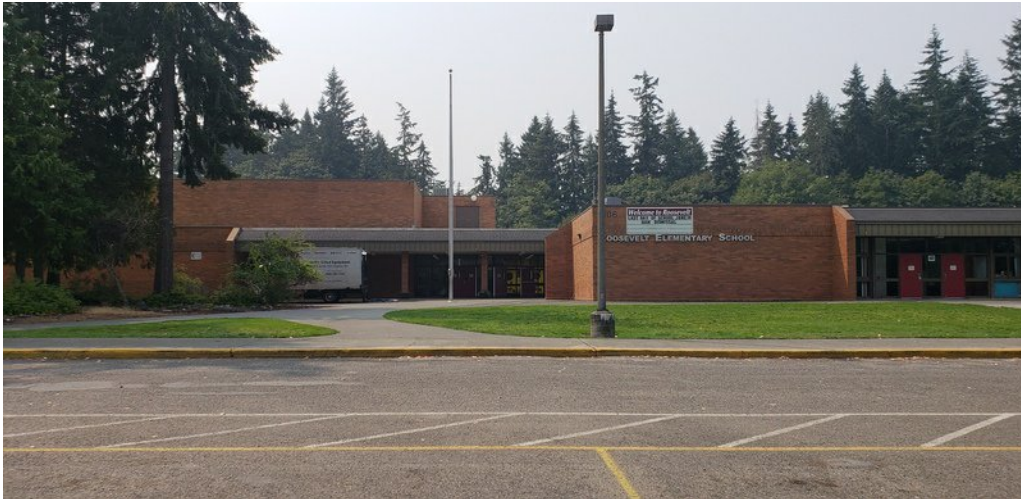
Figure 1-1. Elementary School, Northeast Side with Main Entry

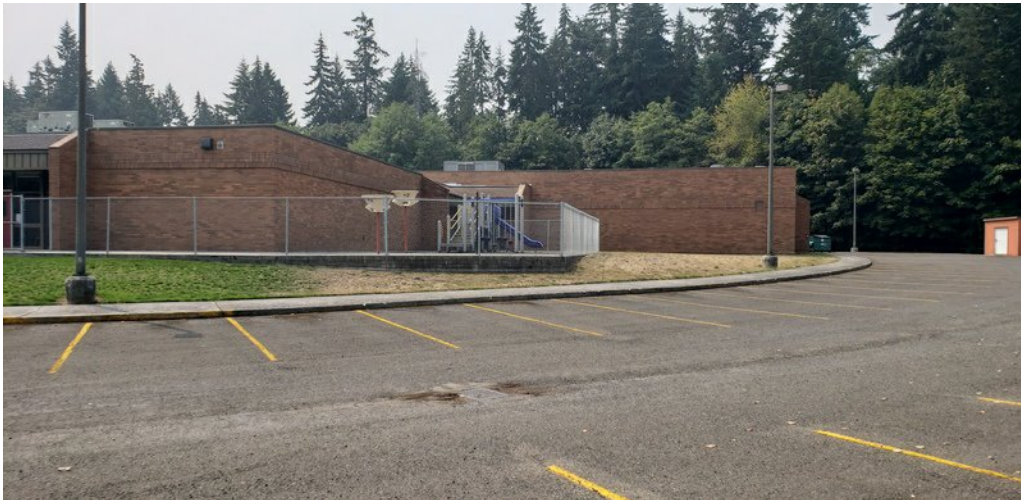
Figure 1-2. Elementary School, North Corner Play Area and Small Retaining Wall

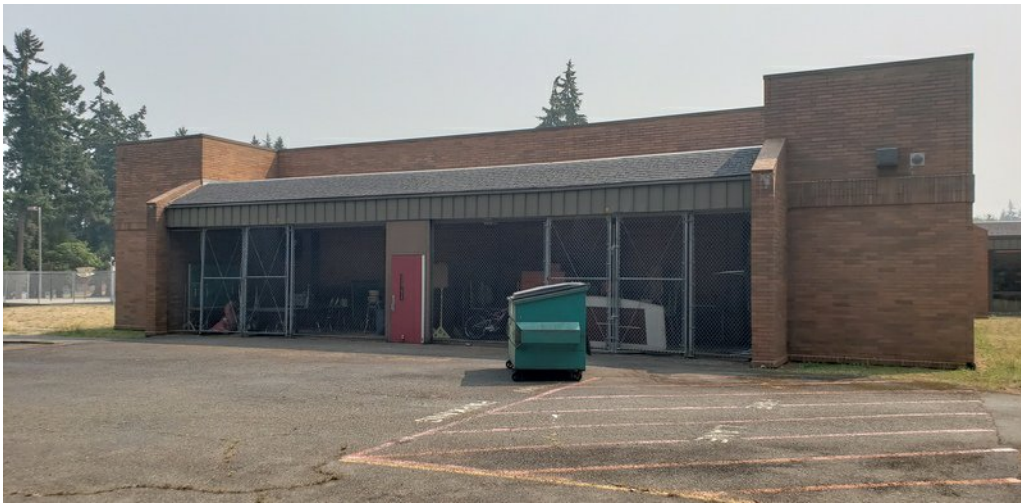
Figure 1-3. Elementary School, North End with Original Shop Area

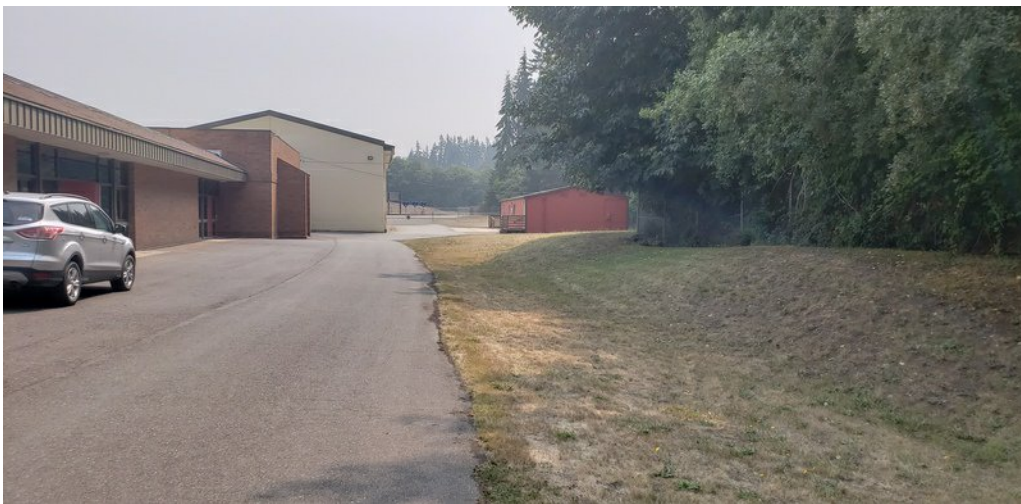
Figure 1-4. Elementary School, West Face (Gym Addition Beyond, Slope to Northeast)

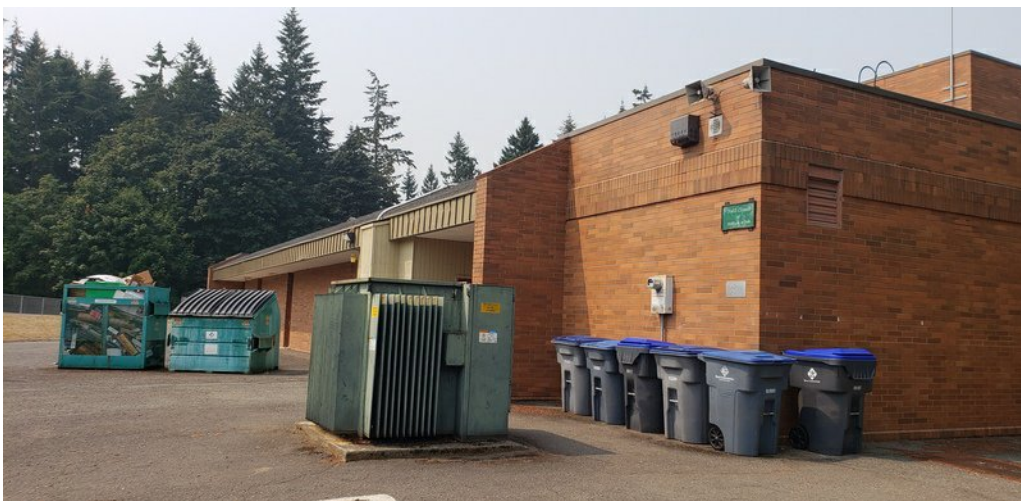
Figure 1-5. Elementary School, Southeast Face with Maintenance Areas

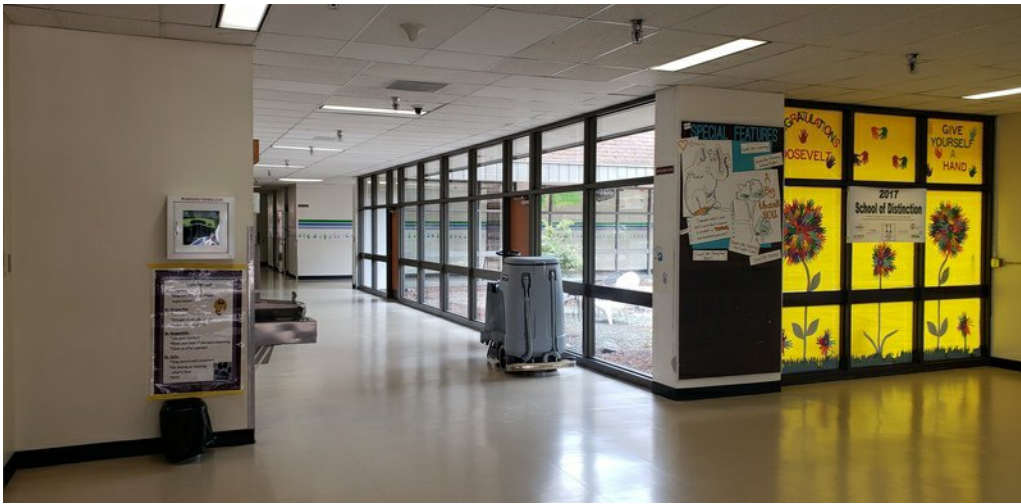
Figure 1-6. Elementary School, Main Entry Corridor and Courtyard

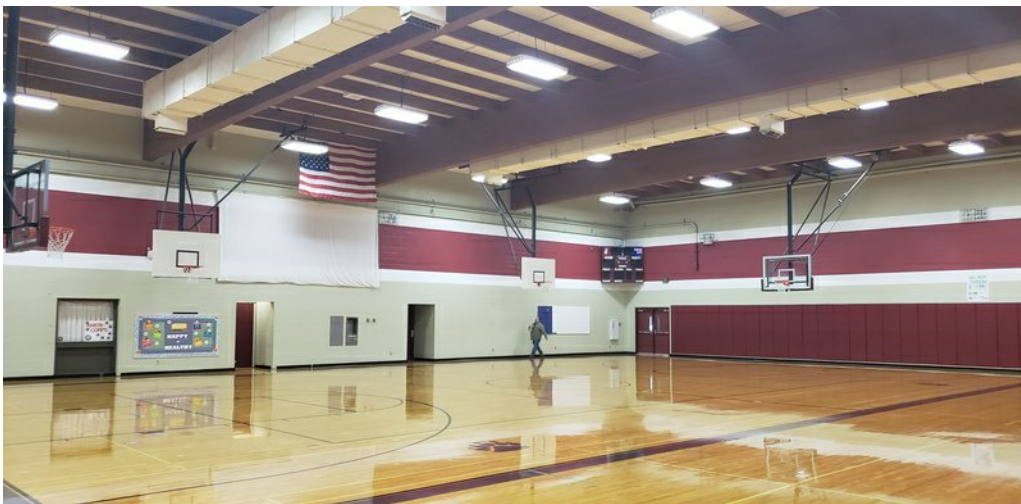
Figure 1-7. Elementary School, Large Gym

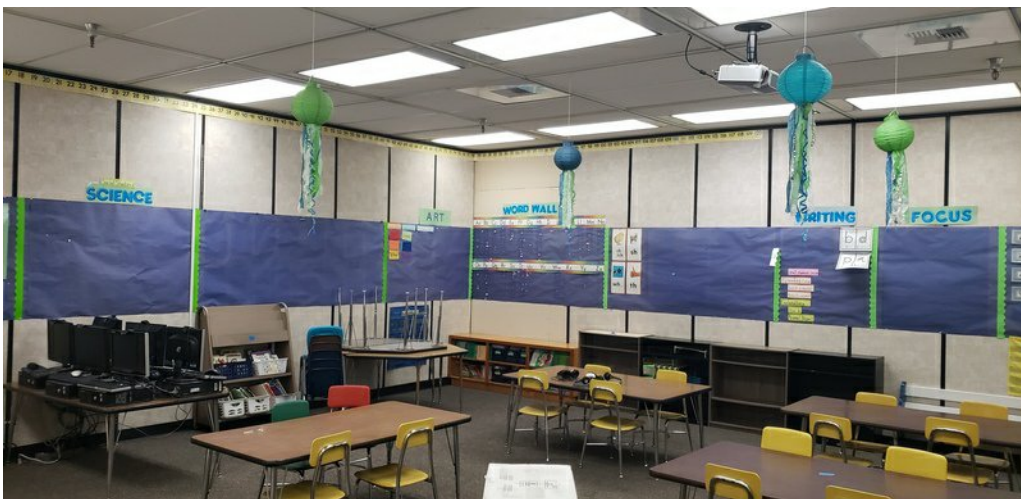
Figure 1-8. Elementary School, Typical Classroom

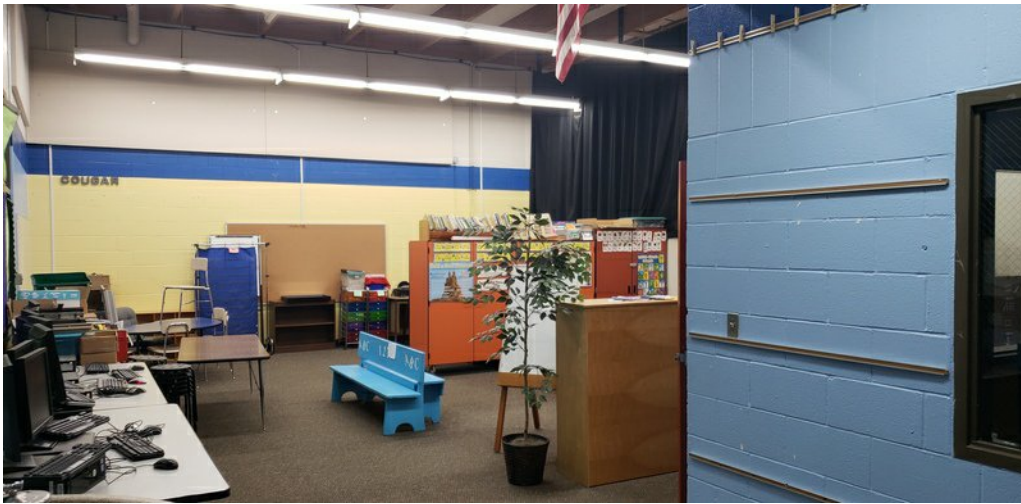
Figure 1-9. Elementary School, Classroom in Former Shop Area

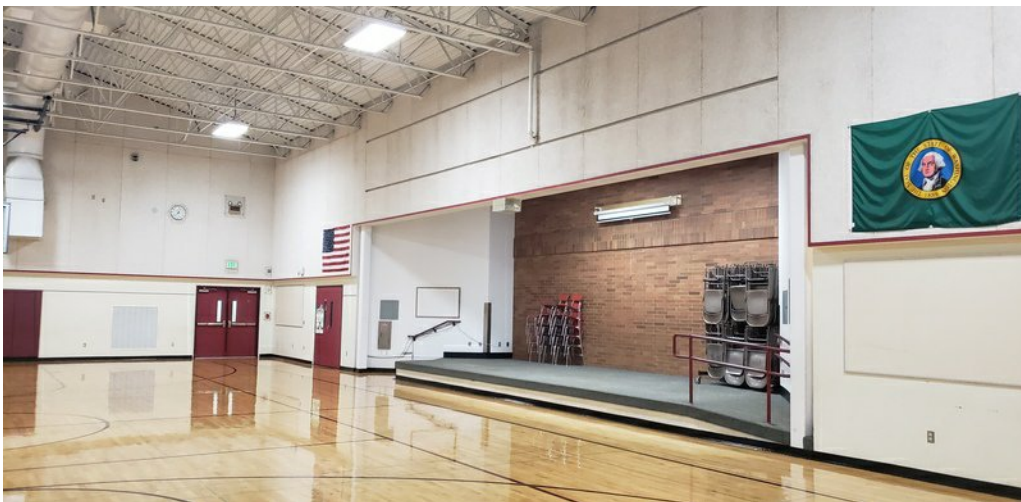
Figure 1-10. Elementary School, Gym Addition with Stage
